west virginia department of environmental protection

**CONSENT ORDER  
ISSUED UNDER THE  
WATER POLLUTION CONTROL ACT  
WEST VIRGINIA CODE, CHAPTER 22, ARTICLE 11**

TO: MarkWest Liberty Midstream & Resources, L.L.C.      DATE: March 28, 2019  
Gregory Bezdek, SVP, NE Region  
4600 J Barry Ct. Ste 500  
Canonsburg, PA 15317      ORDER NO.: 8945

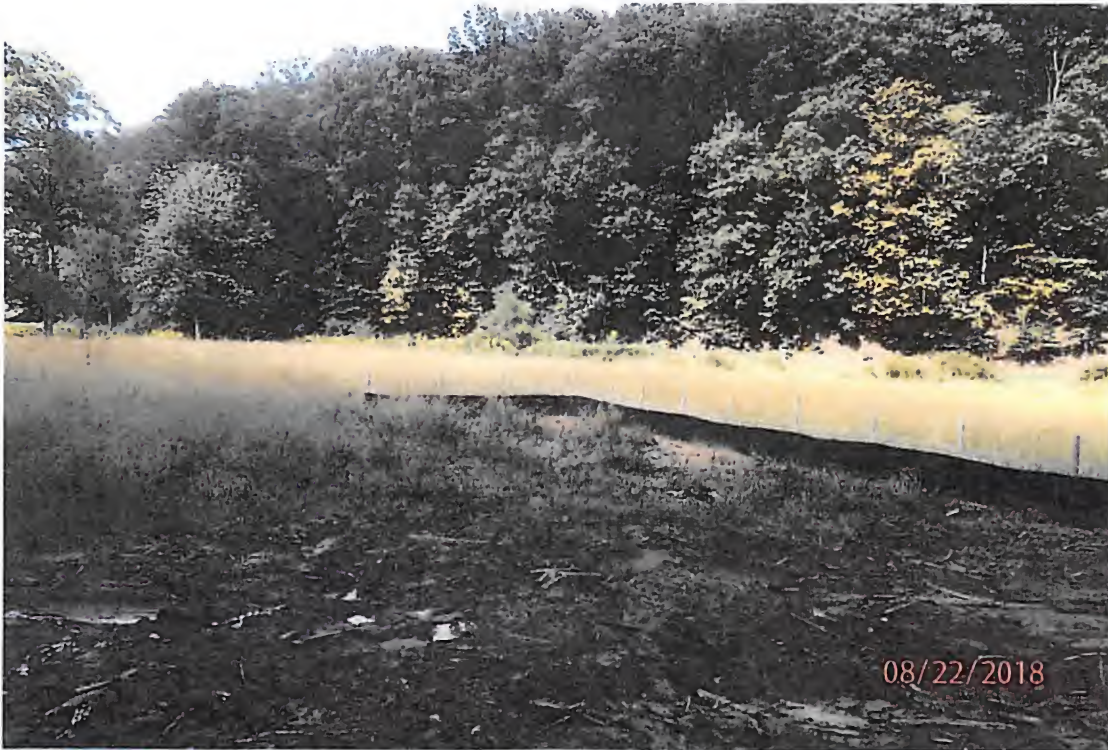
BMP that has been overwhelmed south of the Riggings Run crossing as a result of a lack of installed water bars.

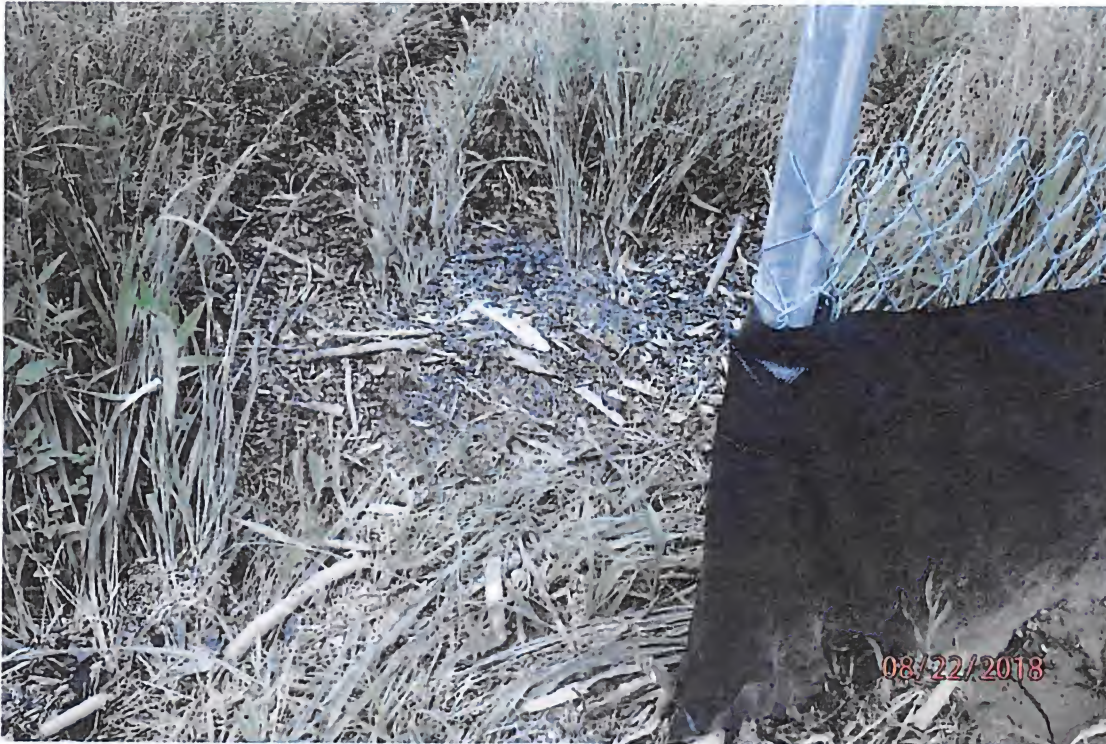
BMP that has been overwhelmed south of the Riggings Run crossing as a result of a lack of installed water bars.

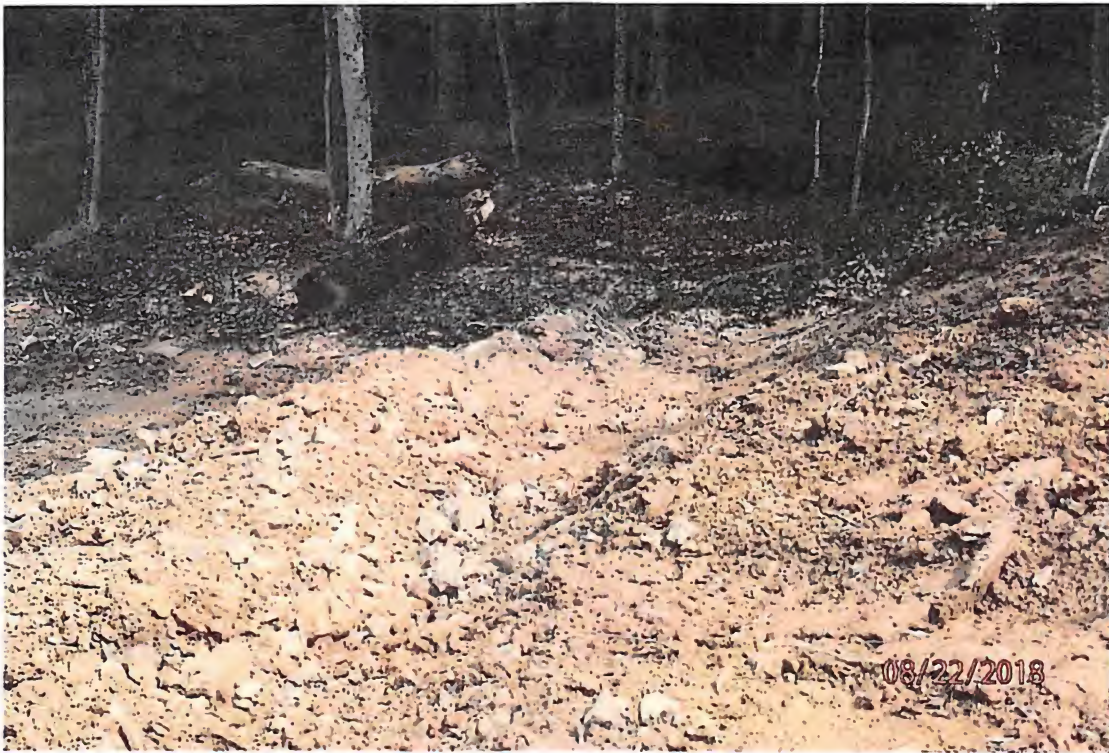
Project area in the Flint Run watershed showing a lack of water bar terminus BMPs.

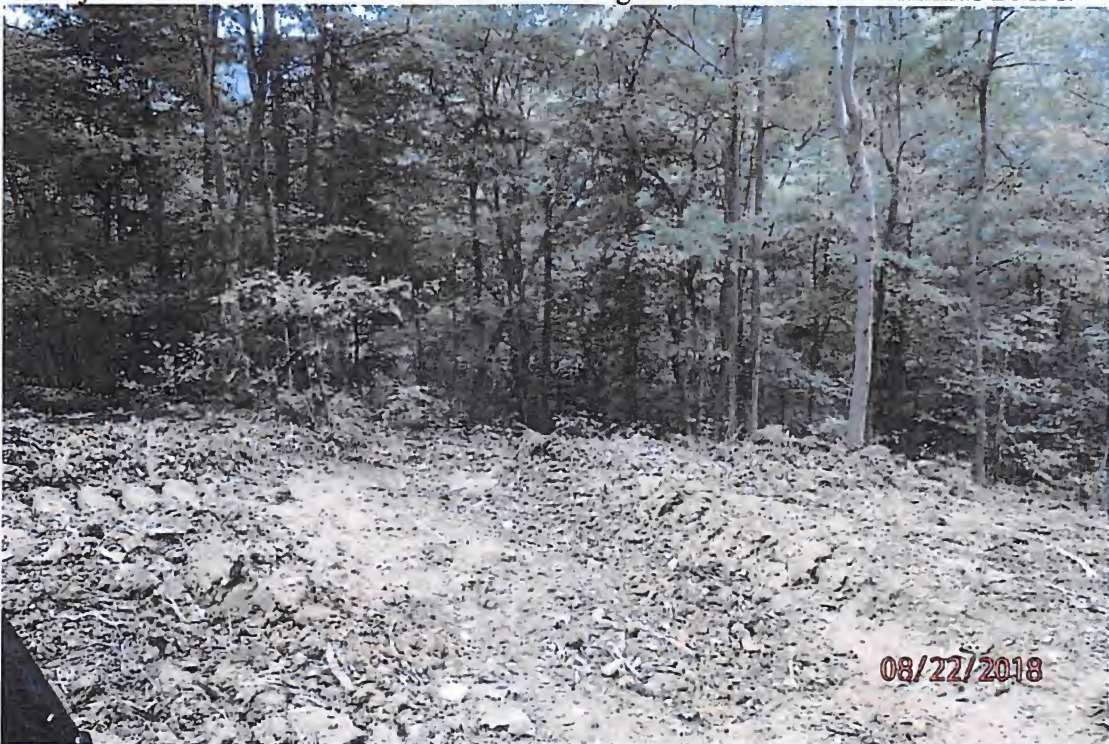
Project area on AR-10 in the Flint Run watershed showing a lack of water bar terminus BMPs.

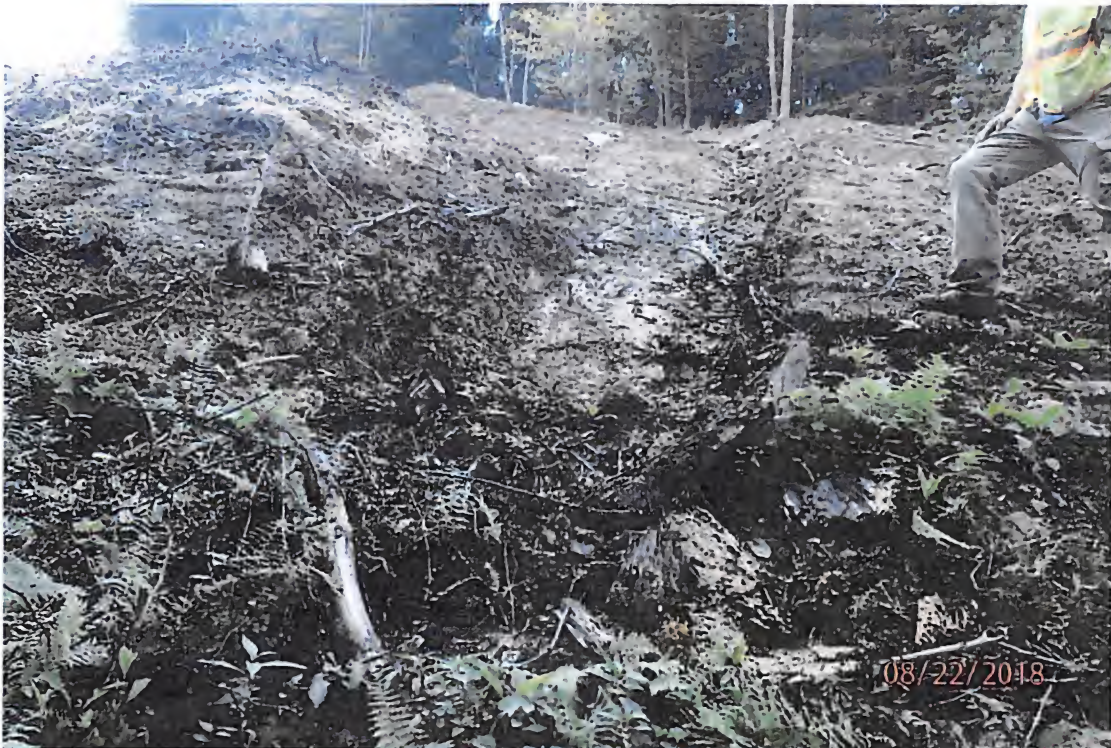
Project area in the Morgans Run watershed showing a lack of water bar terminus BMPs.

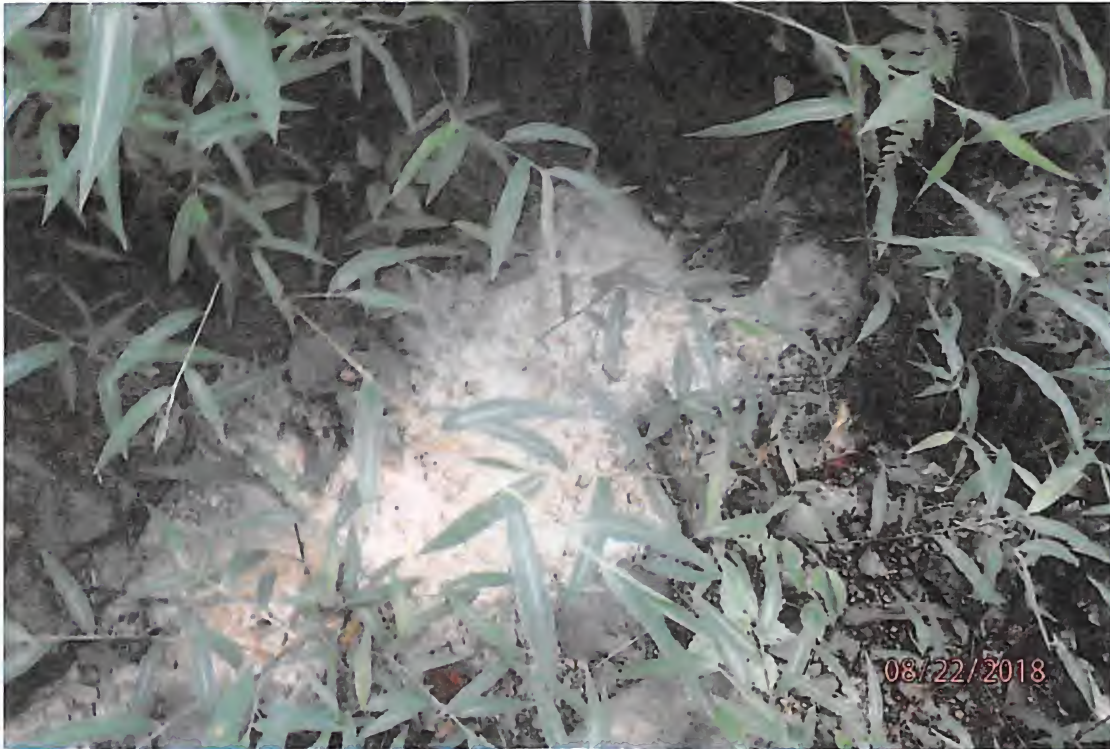
CNA deposits in UNT Morgans Run (UNT 160) ( $39^{\circ} 18.488'$  X  $80^{\circ} 40.335'$ ) as a result of a lack of installed water bar terminus BMPs

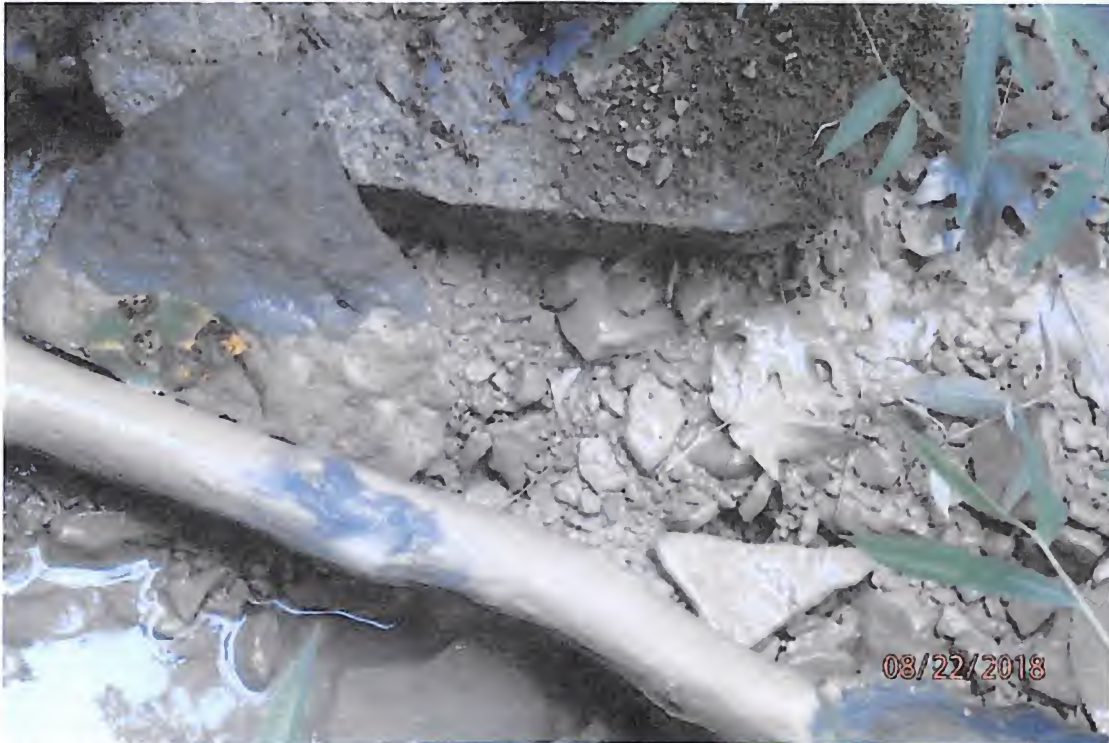
CNA deposits in UNT Morgans Run (UNT 160) ( $39^{\circ} 18.488'$  X  $80^{\circ} 40.335'$ ) as a result of a lack of installed water bar terminus BMPs.

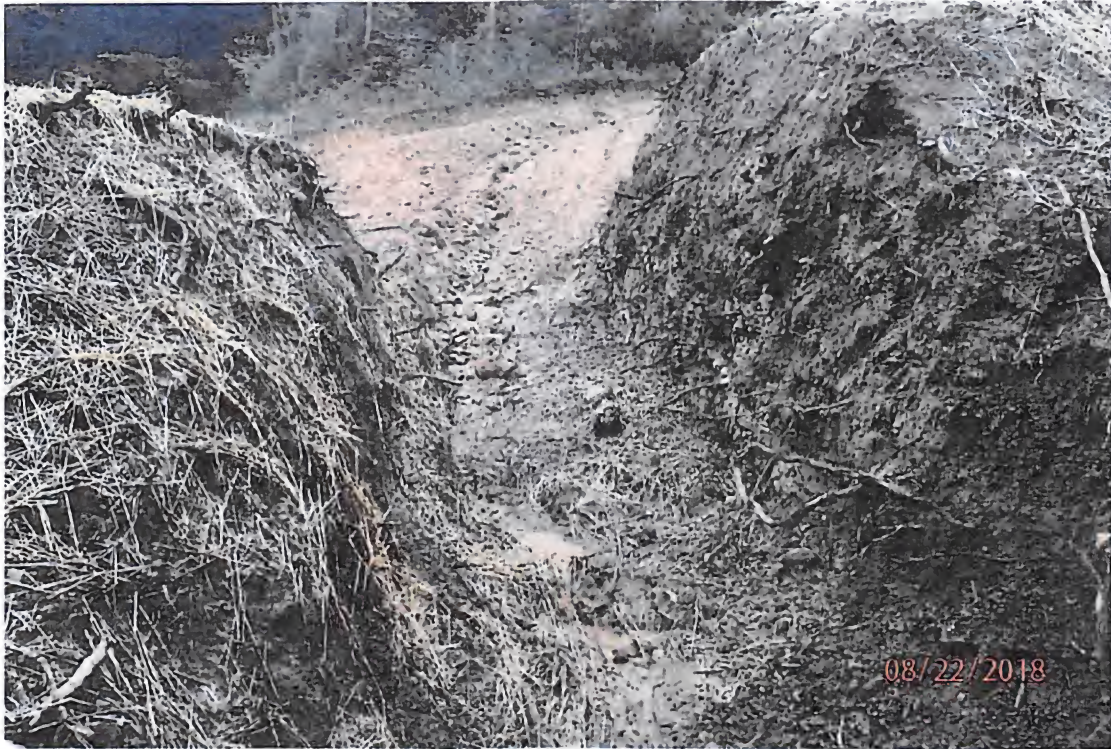
Water bar in the Morgans Run watershed that was installed at a steep angle showing erosion of the BMP.

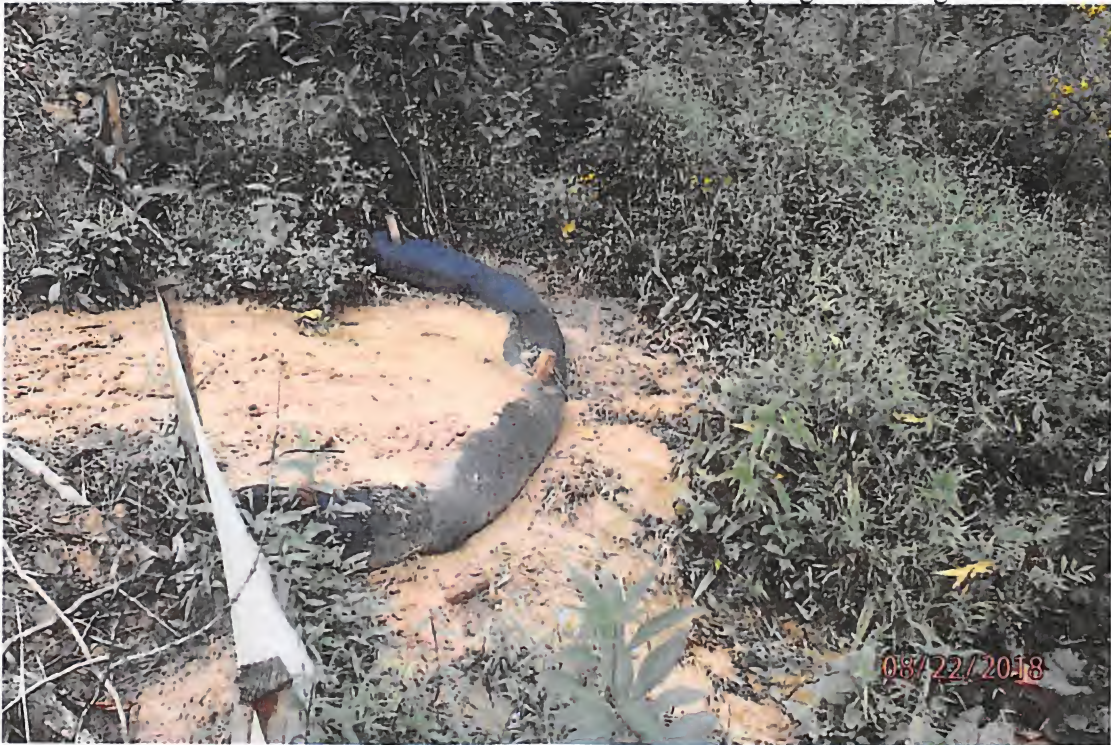
Overwhelmed water bar terminus BMP as a result of excessive erosion from the above pictured water bar.

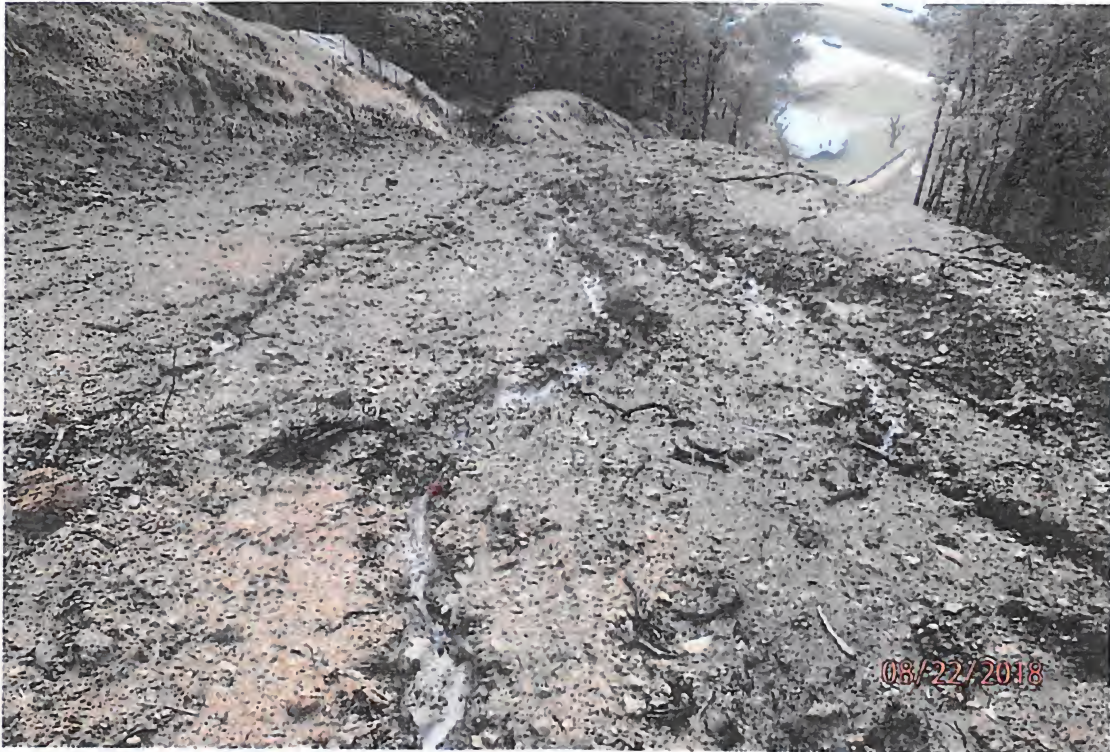
Water bar in the Morgans Run watershed that was installed at a steep angle showing erosion of the BMP.

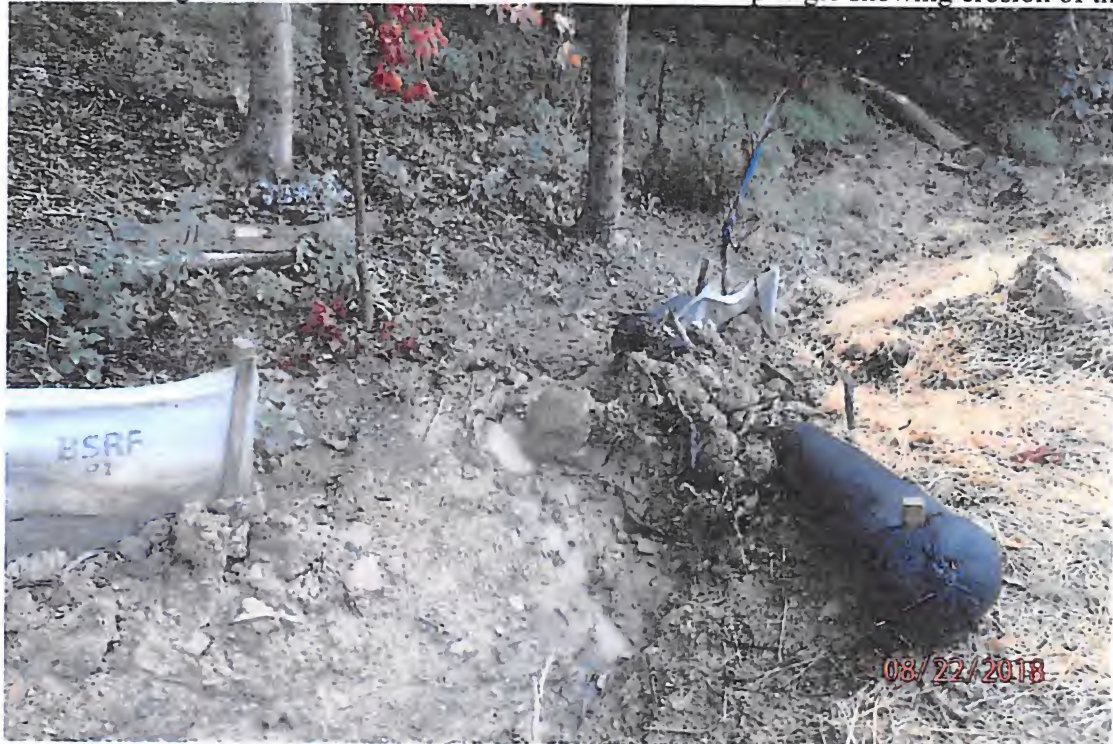
Overwhelmed water bar terminus BMP as a result of excessive erosion and increased water velocity from the above pictured water bar.

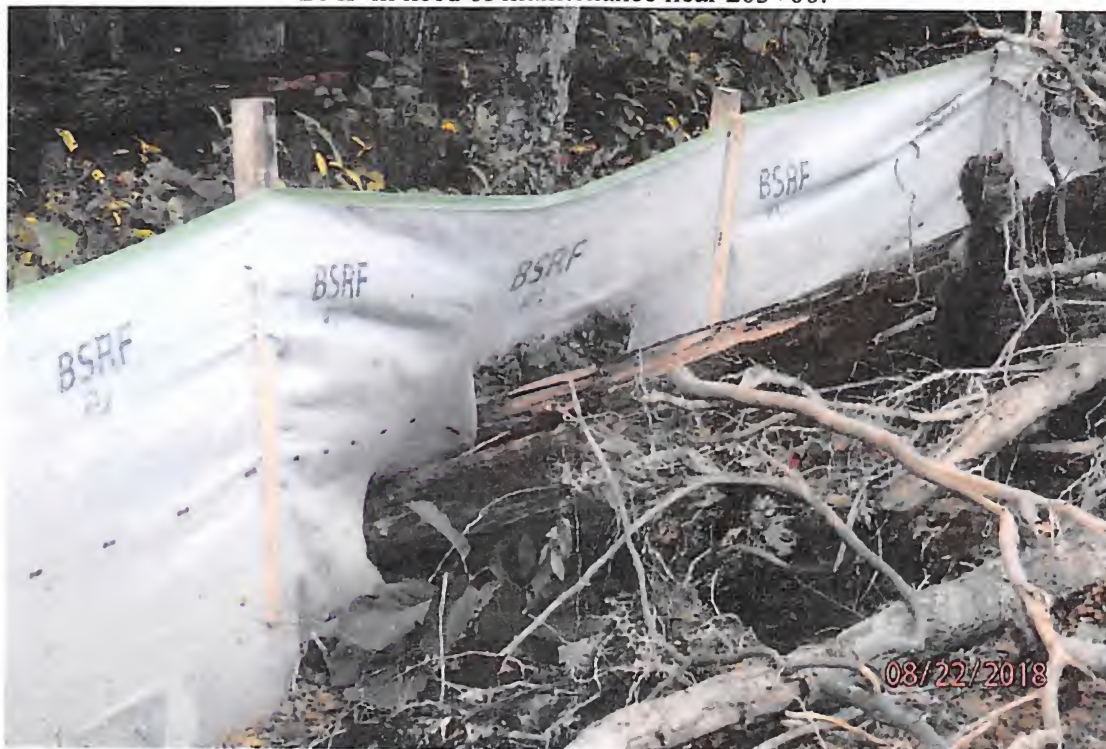
BMP in need of maintenance in the Flint Run watershed.

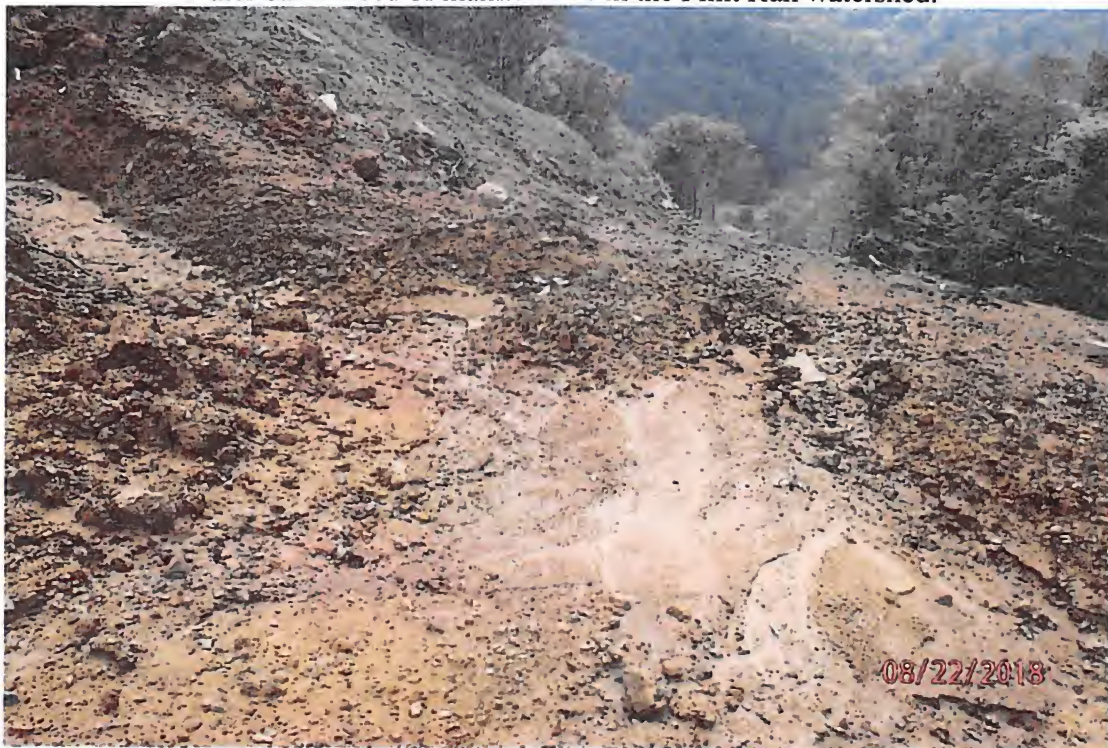
Water bar in need of maintenance in the Flint Run watershed and the associated fill slope erosion.

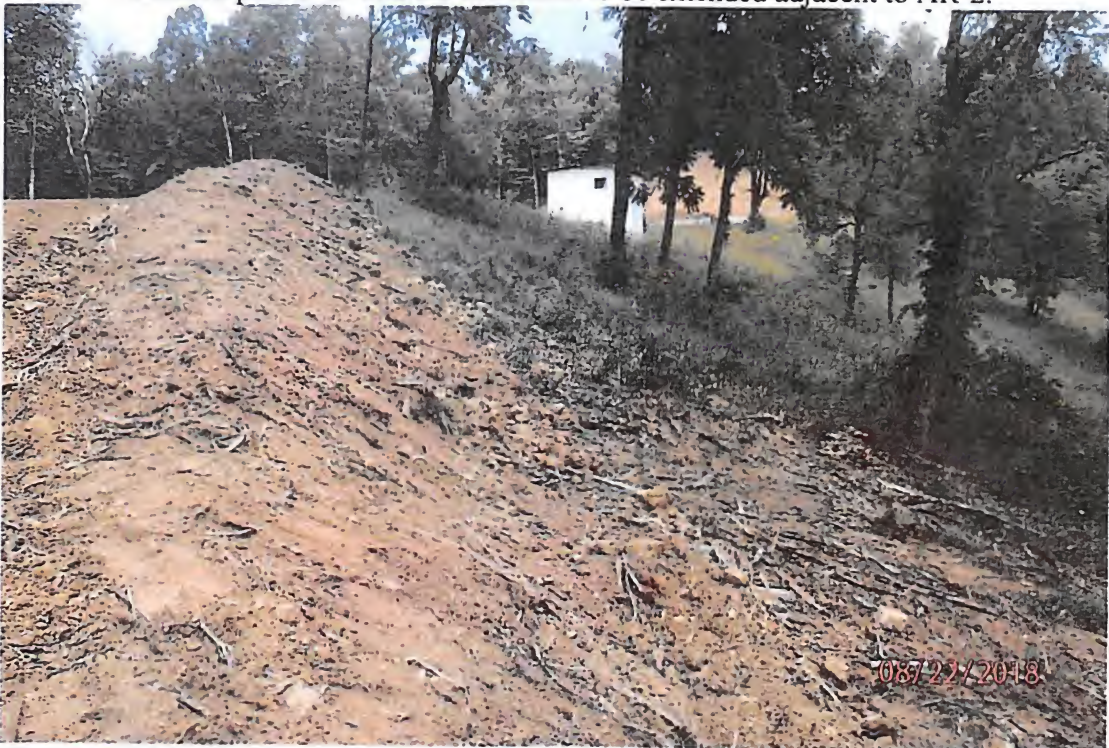
Area adjacent to 158+50 where sediment laden water is leaving the site and no BMP is indicated on the approved SWPPP.

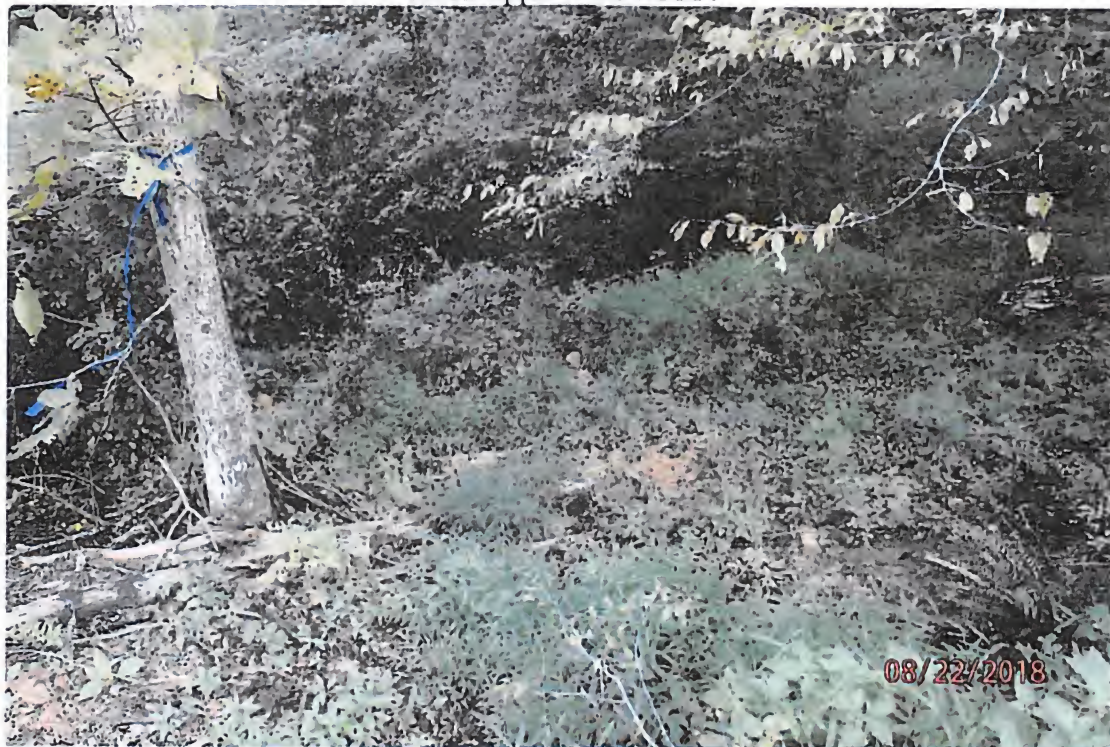
Offsite sediment deposits originating from the above pictured area.

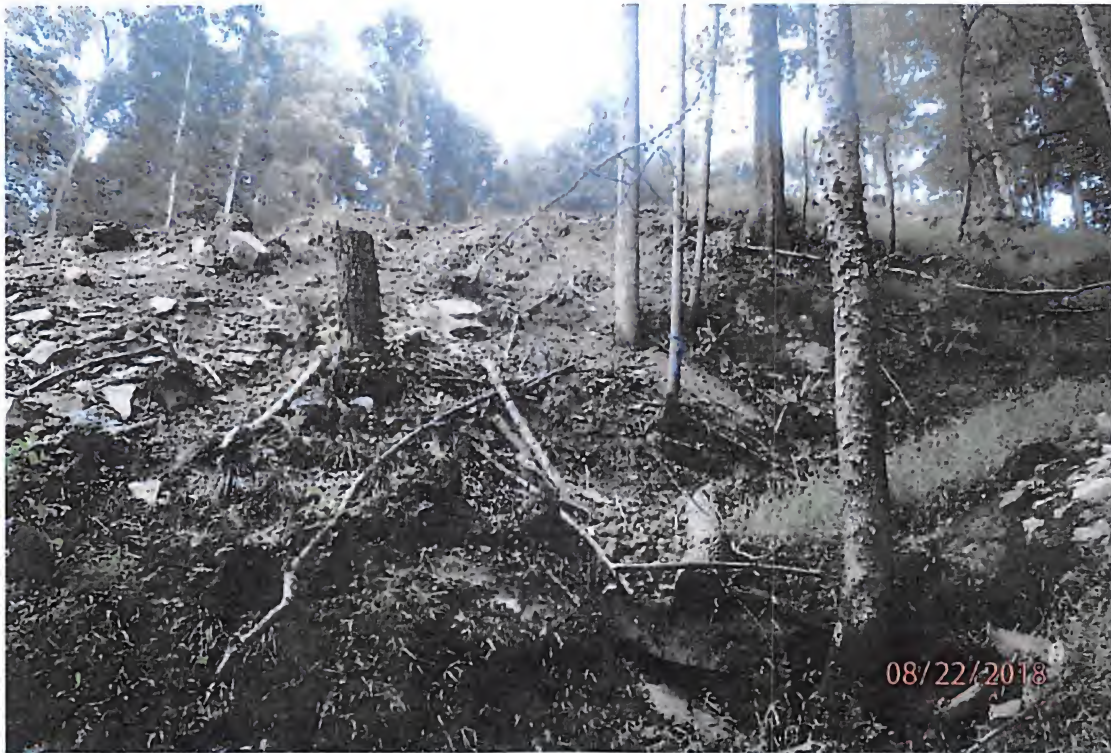
Project area adjacent to 272+00 where sediment laden water is leaving the site and no BMP is indicated on the approved SWPPP.

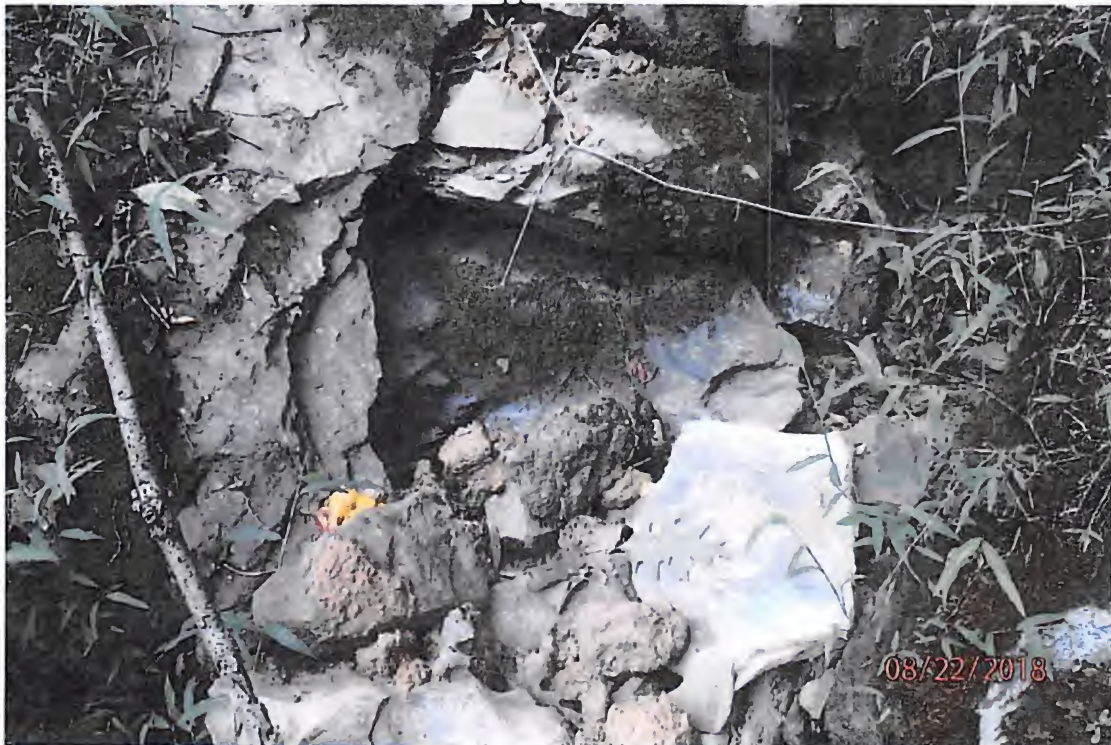
CNA deposits in UNT Flint Run (UNT 94 near 272+00) ( $39^{\circ} 20.051'$  X  $80^{\circ} 39.945'$ ).

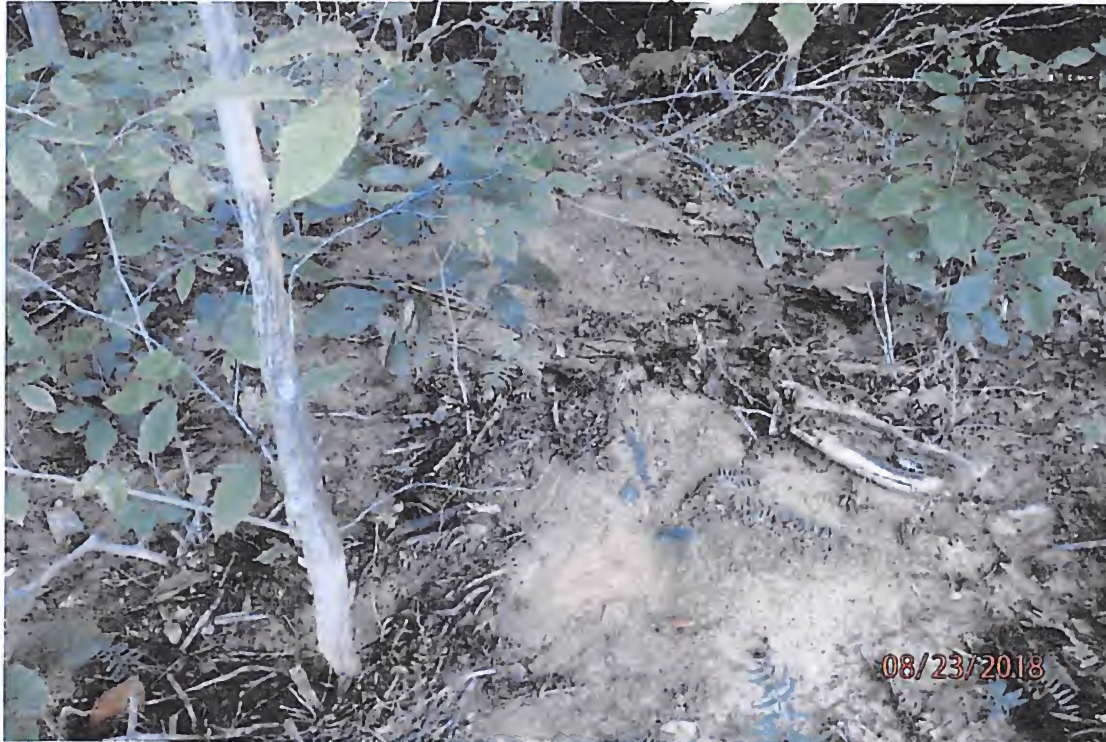
Offsite sediment deposits that lead to the receiving stream as a result of the above pictured deficiency.

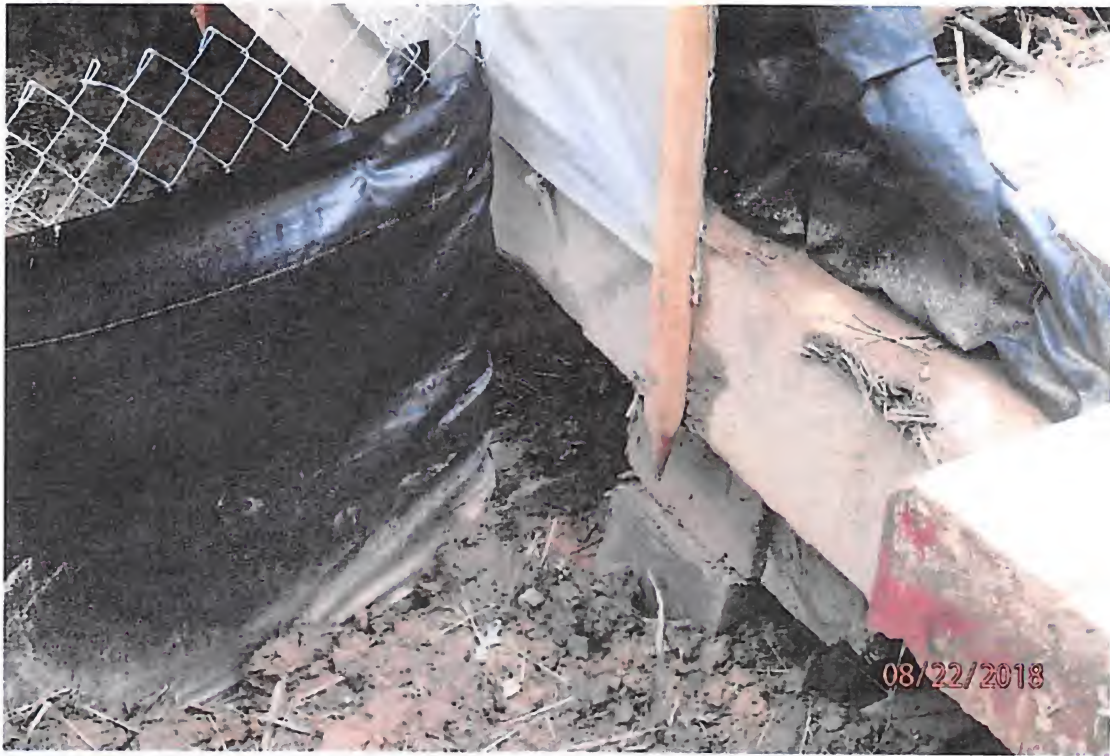
Installed timber mat bridge at crossing 41 (UNT 18) that is not tied in properly.

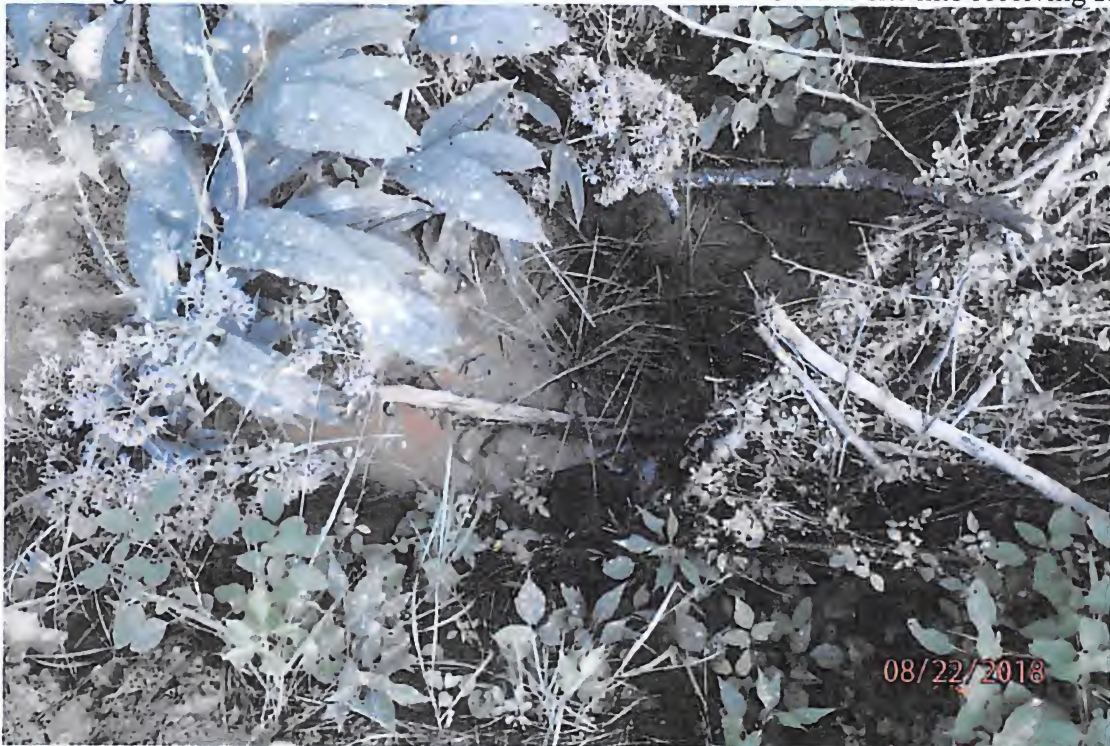
Offsite CNA deposits and distinctly visible settleable solids in UNT Franks Run (39° 26.230' X 80° 36.769').

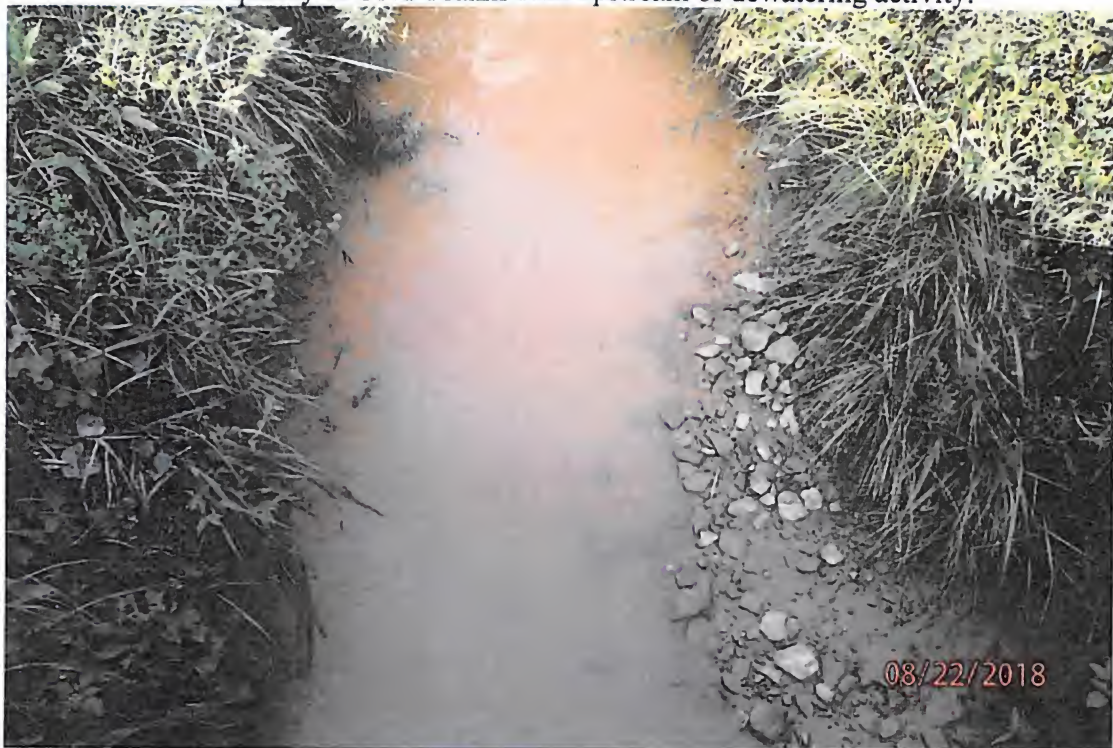
Offsite CNA deposits and distinctly visible settleable solids in UNT Franks Run (39° 26.167' X 80° 36.861') downstream of the dewatering activity.

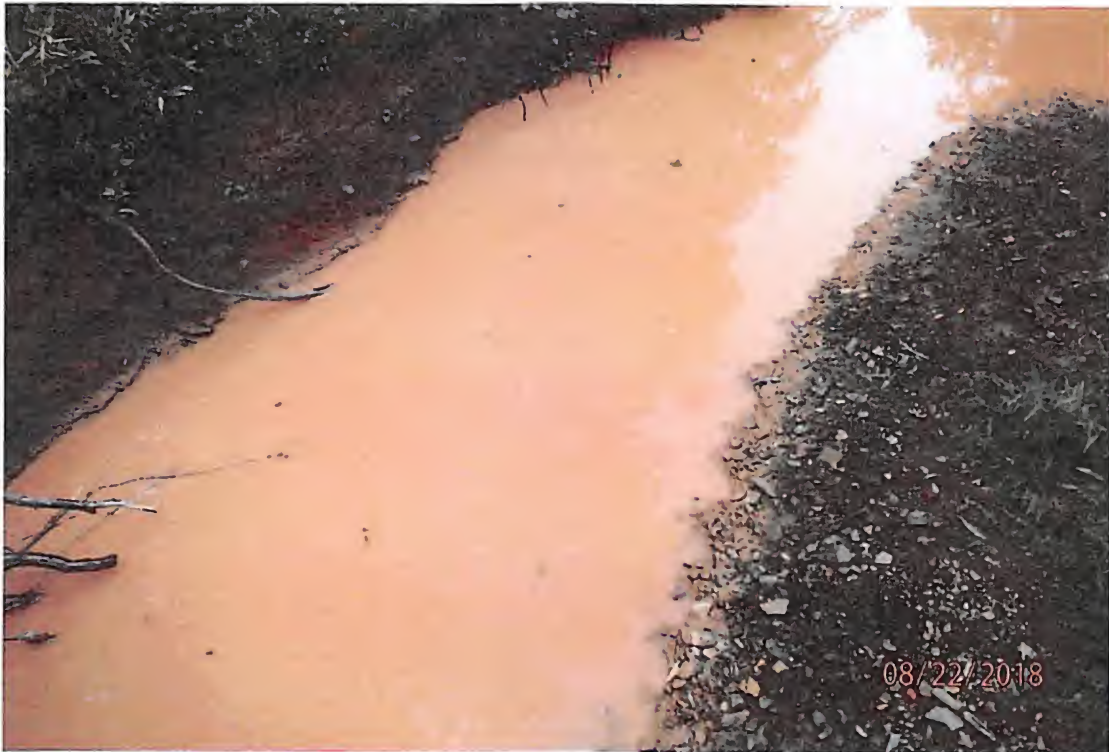
Offsite CNA deposits and distinctly visible settleable solids in UNT Franks Run (39° 26.167' X 80° 36.861') downstream of the dewatering activity.

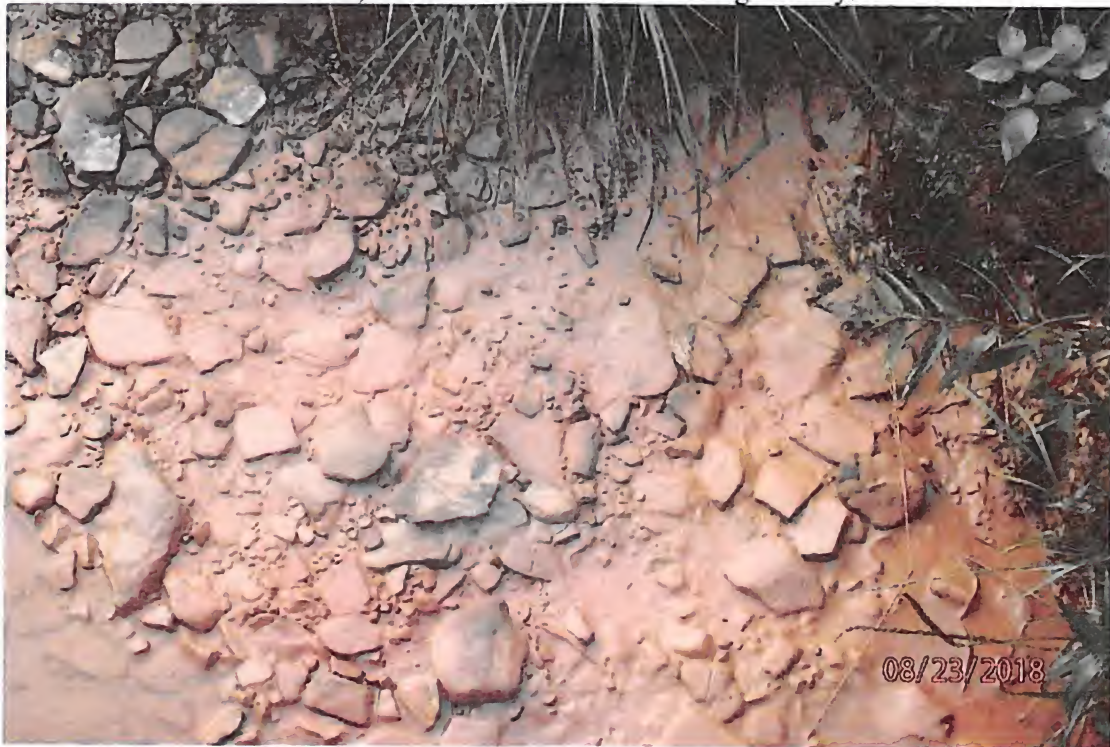
Offsite CNA deposits and distinctly visible settleable solids in UNT Franks Run (39° 26.167' X 80° 36.861') downstream of the dewatering activity.

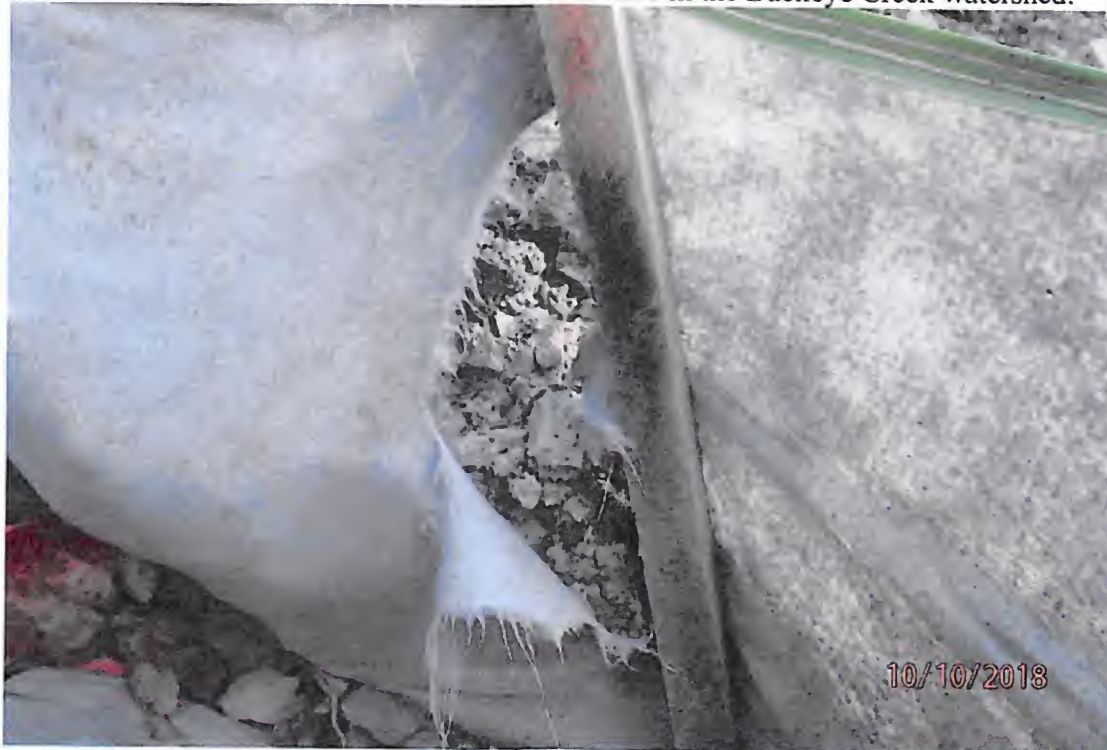
Perimeter control in need of maintenance in the Buckeye Creek watershed.

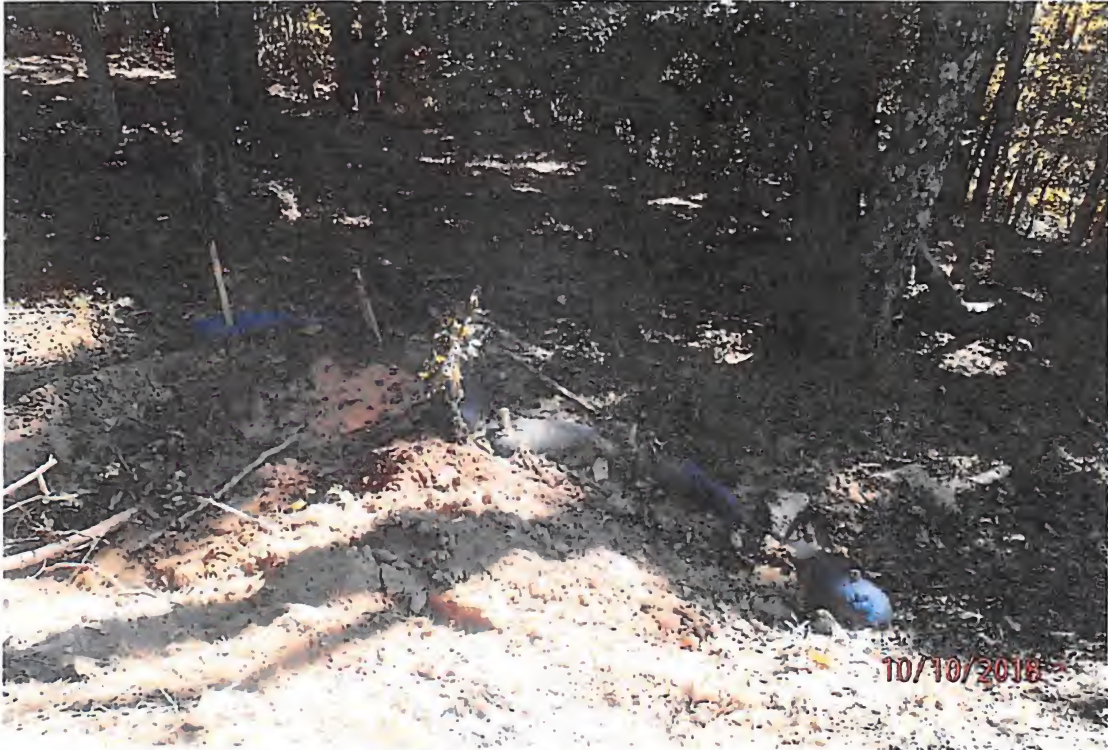
Water bar terminus BMP in need of maintenance adjacent to 153+00.

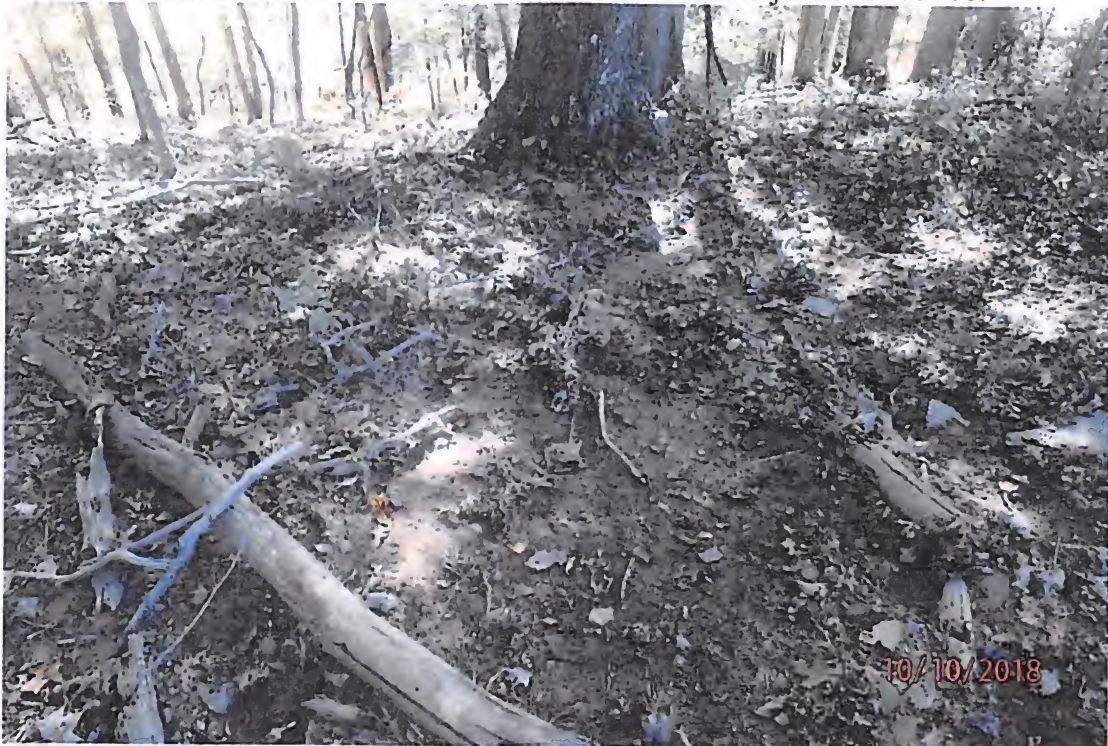
Offsite sediment deposits downslope of water bar terminus BMP adjacent to 153+00.

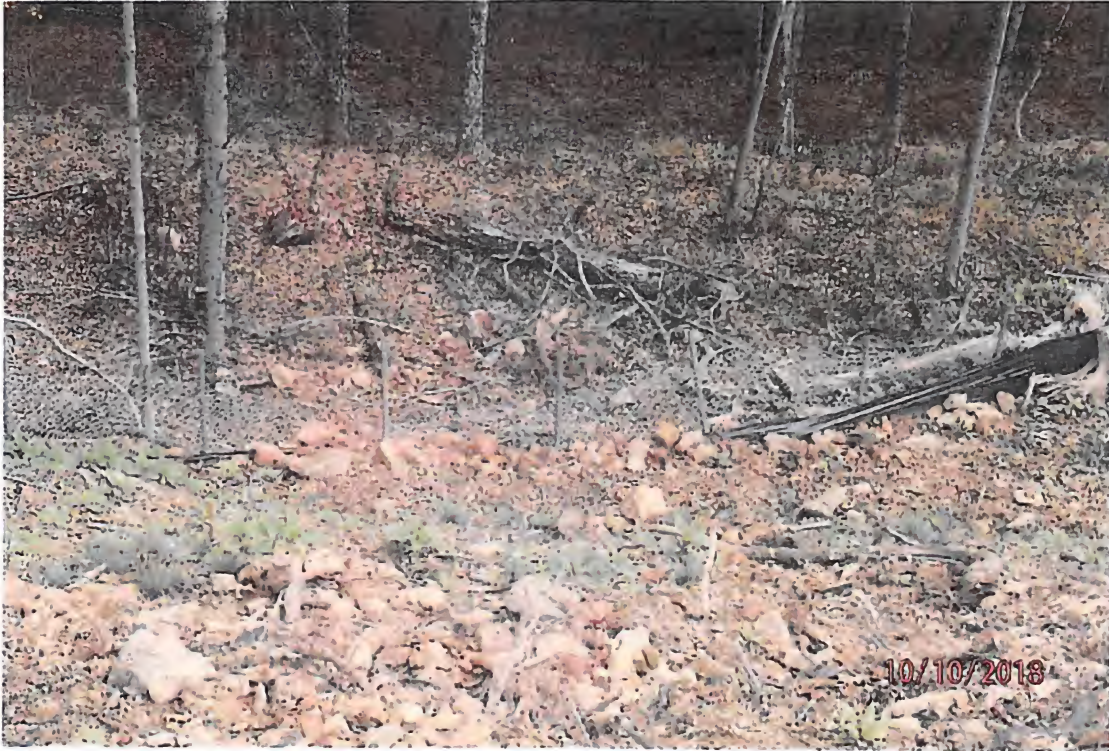
Perimeter control in need of maintenance in the Flint Run watershed.
